PROJECT PROFILE

Project:
C.M.R.S.
Columbus, Georgia

Roofing System:
Adhered Décor Roof
using 60 Mil Feltback
PVC membrane

Dry Tech ends years of roof leaks once and for all!

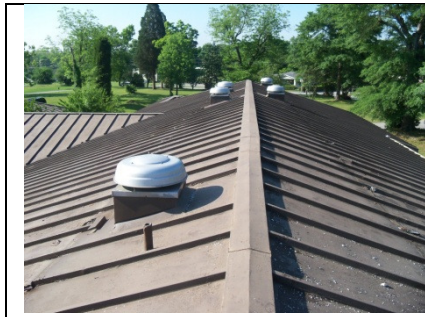
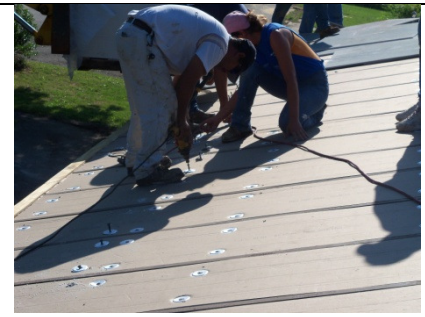
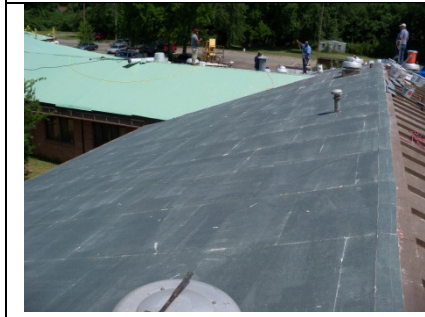
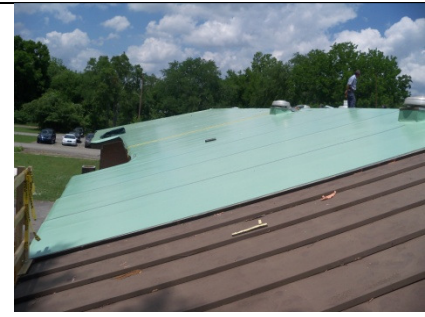
Dry Tech Engineering prepared specifications and details for installation of the new Décor system over the techtum roof deck and existing metal roof to meet FM I-60 wind uplift requirements. The old wall uprights were cut flush to the roof panels. It was critical to achieve a level substrate to adhere to. This meant no margin for error in design and installation. "We were fortunate that the metal battens on the old roof were 1-1/2" high so the isoboard would be even, otherwise we would have had to remove the battens", said Brad Jordan of M Jordan Roofing. The densdeck cover board was fully adhered and had to be level throughout, with tight board joints. "The wood nailer along the perimeter of the roof made it easier to start the cover board and gravity made it easier to keep the boards tight during installation", said Jepson. "The contractor did not rush the installation as the densdeck had to be exact in measurement and fit. No gaps were allowed as any anomalies in the field of the roof would be visible and alter the intended look of a standing seam metal roof."

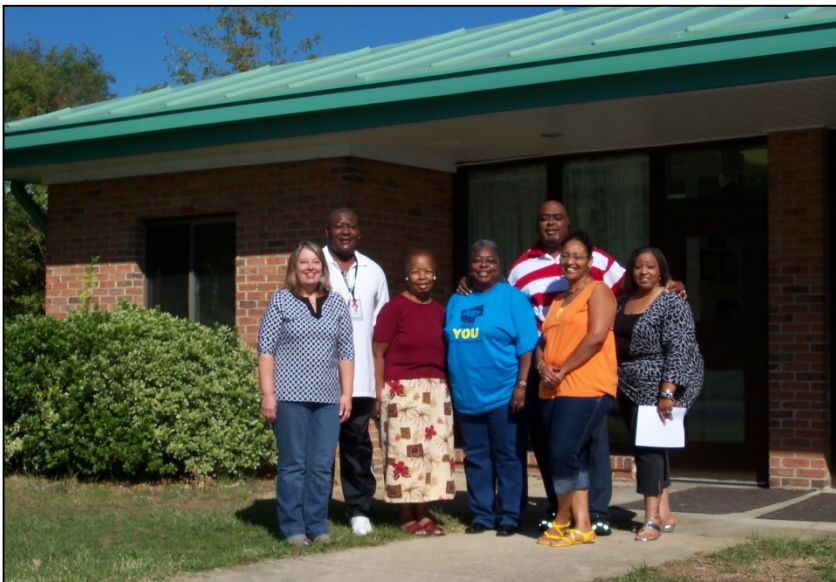
Driving up to this facility, you would never know that it is not a standing seam metal roof. Very clean lines throughout along with brand new skylights, gutters

and downpouts make this building look brand new. More important, the facility is now 100% leak free.
